SHOCK CORDS

Know when to change them

ARTICLE AND PHOTOS BY H.G. FRAUTSCHY

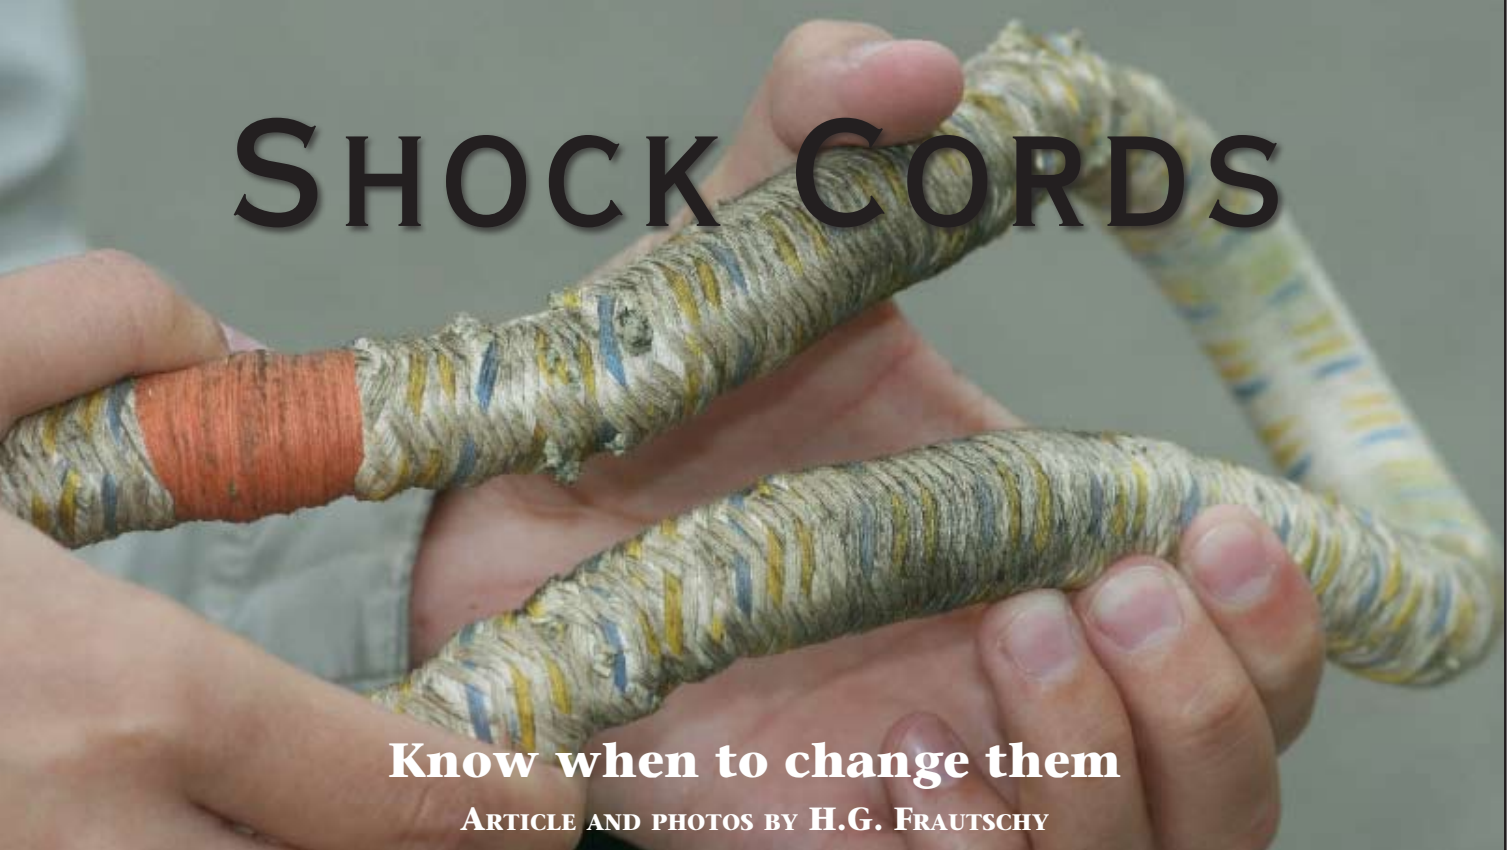
A serviceable cord should have a smooth outer covering, with no bumps or disruptions to the woven cover. This one looks good, but age and repeated landing cycles have taken their toll.

Even when the cords have been well protected, the interior of the shock cords will deteriorate over time and will need replacement. Evidence of that wear is most often seen in the form of surface irregularities in the covering.

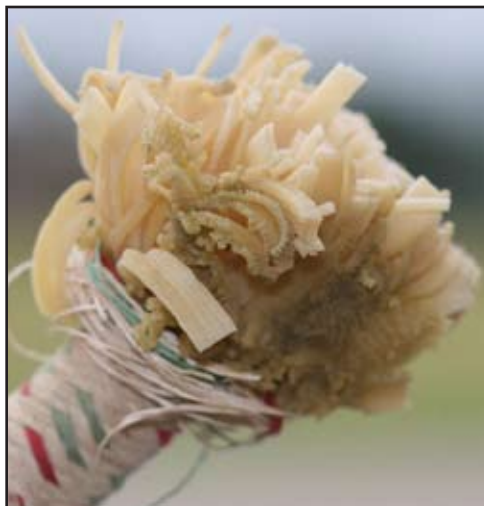
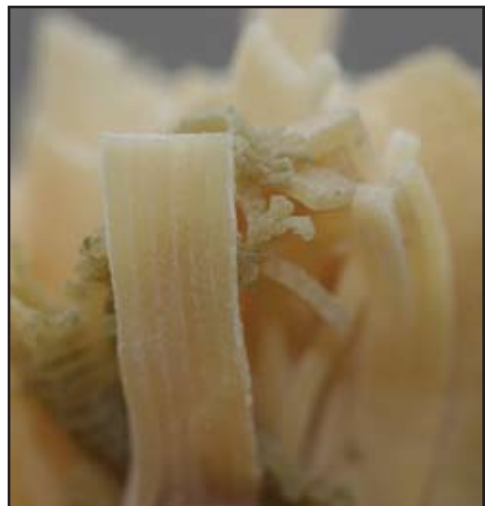
No, it’s not some new exotic pasta dish, or an undiscovered sea creature. The outer rubber strands show signs of environmental aging, as ozone and airborne contaminants (including engine exhaust chemicals) attack the rubber. You can see how the inner strands are less affected. Again, this shock cord didn’t appear to be excessively worn when viewed from the outside; the damage was only obvious once the covering was cut away.

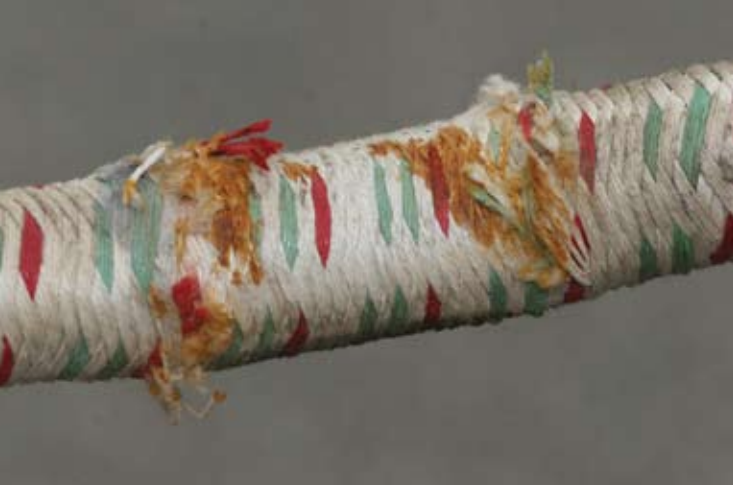
This same cord showed some signs of abrasion damage to the woven covering where the shock cord was in constant contact with the landing gear structure.

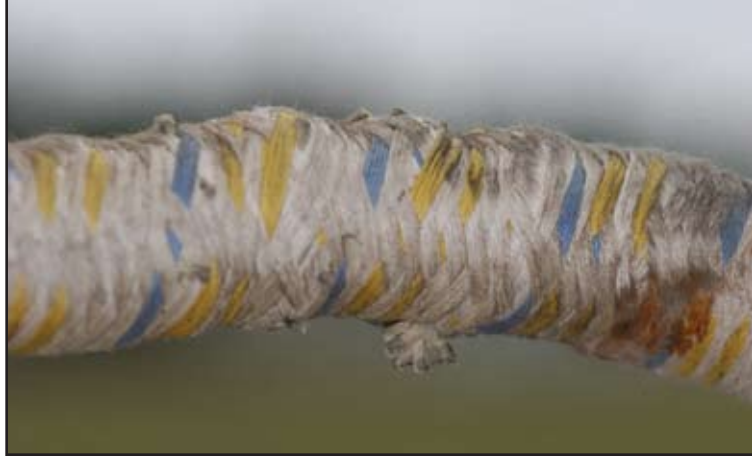
This cord shows obvious signs of damage to the outer covering and to the rubber strands inside. The bumps and breaks in the covering indicate many broken strands of rubber inside the shock cord. This cord must be replaced.

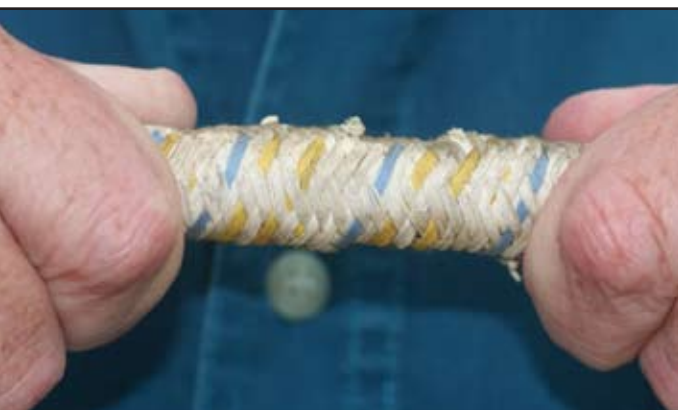
Most normal humans would not be able to pull on a 3/4-inch shock cord and be able to stretch it, but this cord had deteriorated to such an extent that it was possible for me to do so!

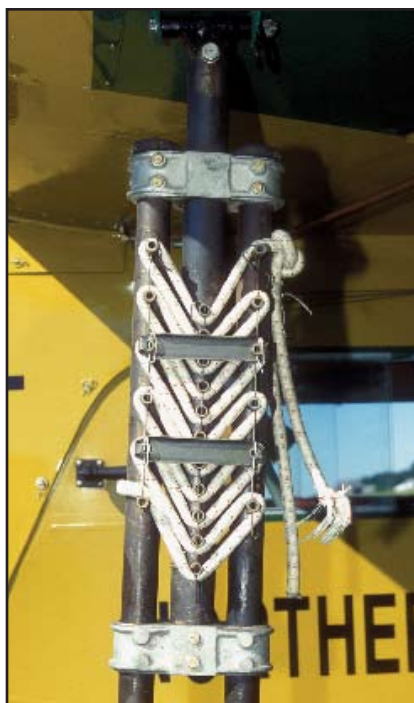
Some aircraft use multiple shock cords. This is the upper end of the landing gear of a Fokker Super Universal. A similar herringbone arrangement was used on the Ryan NYP, Spirit of St. Louis.
